STUDY OF THE CORROSION OF LOCOMOTIVE BOILER TUBES

C. C. CONGDON

ARMOUR INSTITUTE OF TECHNOLOGY

1915

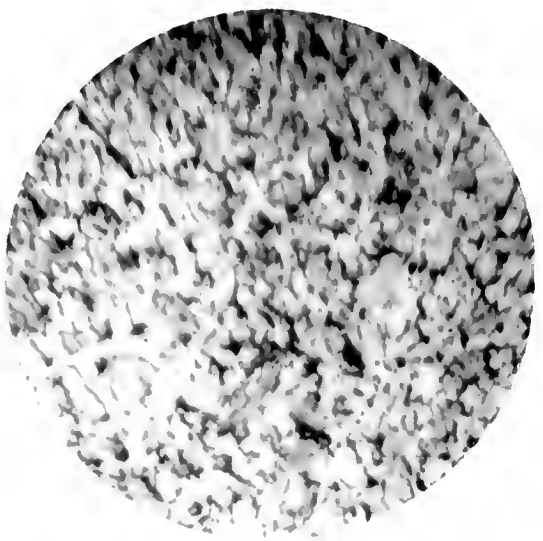
The above is a transverse section of a mild steel tube magnified 240 diameters. It shows clearly the ferrite grains.

From longitudinal section of mild steel tube. Magnification 240 diameters.

Magnification: 240 dia. A spot of segregated impurities brought to surface by working.
